High Impact and Improved Corrosion Resistance for Bone Cutting Tools

By: Debbie Arnott, Orchid Orthopedic Solutions Sheffield Ltd
Tom Smith, Orchid Orthopedic Solutions Sheffield Ltd

High Impact and Improved Corrosion Resistance 17-4PH Stainless Steel for Rasps, Broaches and Other Bone Cutting Tools

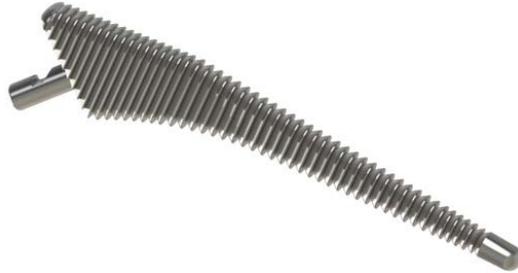
The hip broach (Figure 1), or rasp, is used during implant surgery to form the cavity in the bone into which the hip stem will be implanted. It is manufactured to the same shape as the hip stem with serrated edges to allow removal of the soft tissue and spongy bone from the center of the femoral bone.

Figure 1 – Example of a Hip Broach showing serrated cutting edges.

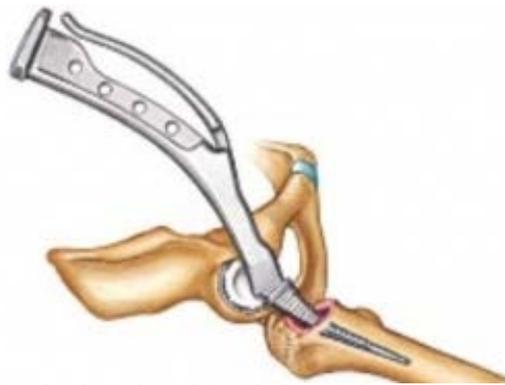
The broach/rasp is inserted into the bone cavity by the use of a detachable handle (Figure 2,) which is attached to a spigot at the end of the rasp stem. The rasp is then repeatedly driven into the cavity by impact force to form the cavity.

Figure 2 – Image showing insertion of the Hip Broach into the Acetabular canal with the use a detachable handle.

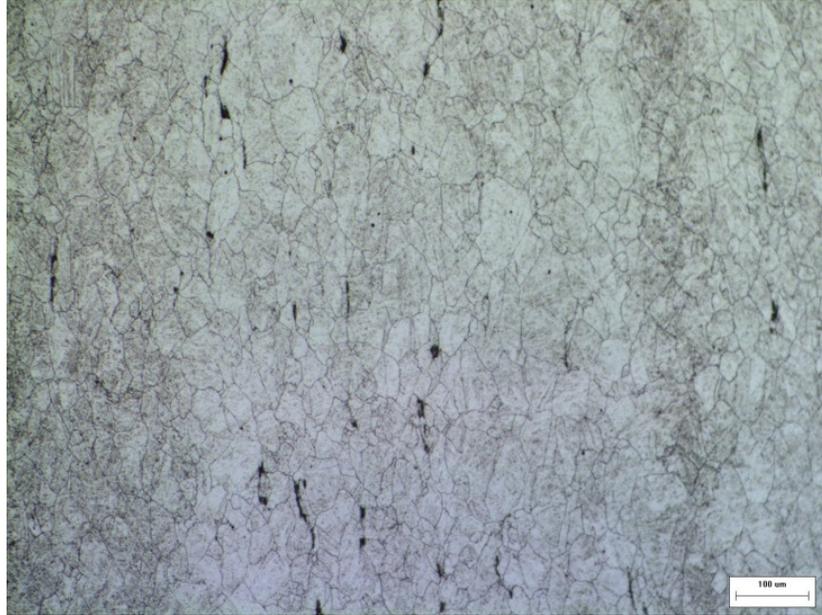
The Standard wrought products in the H900 Condition displayed a matrix of lath martensite and the precipitation of ϵ -Cu phase⁽⁵⁾ (figure 3). Grainsize was deemed acceptable in accordance ISO 643 and gave an overall measurement of 5⁽⁹⁾.

Figure 3- Microstructure of the Standard wrought 17/4PH Stainless Steel in H900 Condition

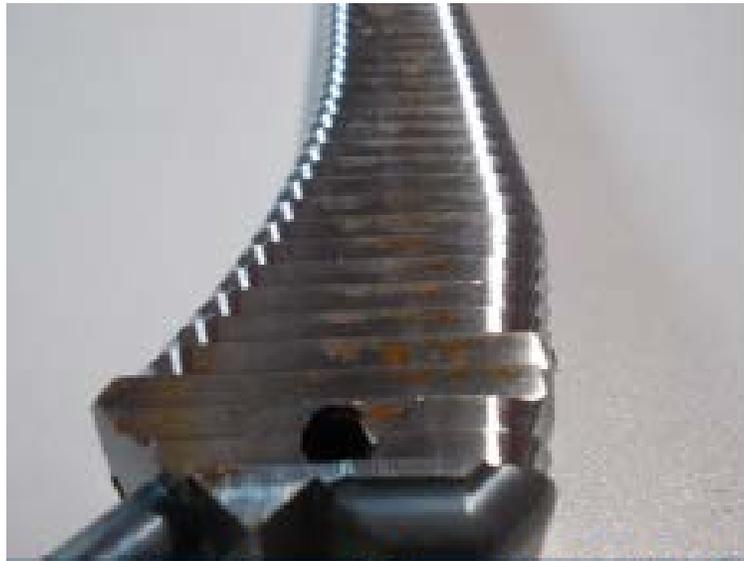
On completion of the test, the Standard wrought product showed evidence of pitting corrosion which initiates from the cutting edges of rasp instruments (Figure 8).

Figure 8- Standard wrought broach showing evidence of Pitting corrosion

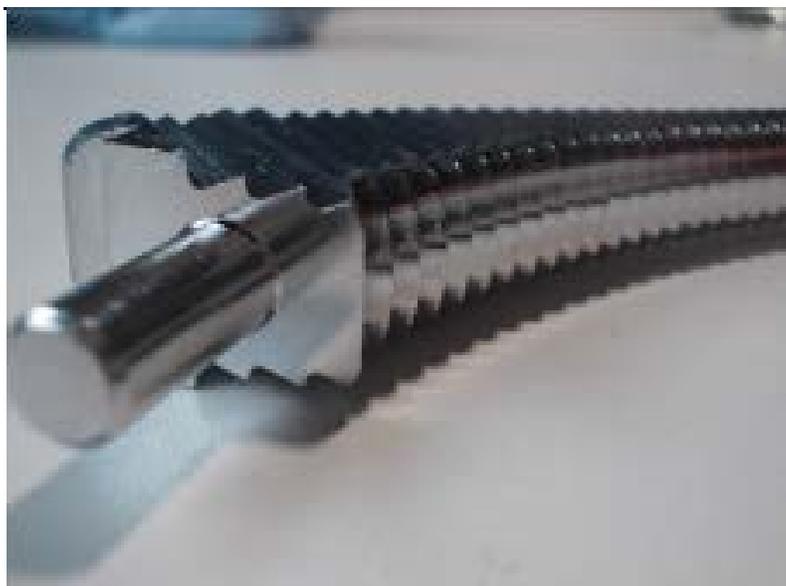
In comparison the Orchid Broach remained in polished condition with no evidence of the corrosion putting on the machined surface (Figure 9)

Figure 9 – Orchid Broach product after Salt Test

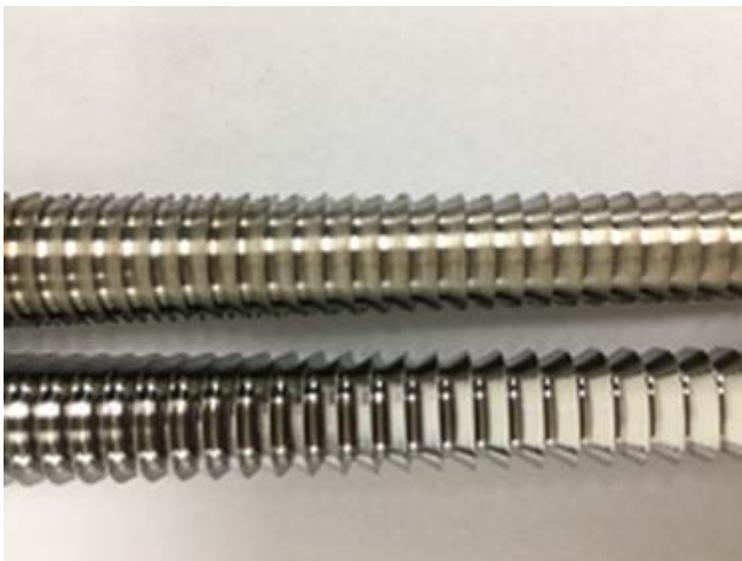
On completion of the autoclave testing, there was no evidence of pitting corrosion. However, after 11 cycles the Standard wrought material displayed a discolouration which was maintained throughout the process (Figure 10). The Orchid product maintained and polished surface after 40 off autoclave cycles.

Figure 10 – Photograph showing discolouration of wrought product at 11 autoclave cycles and Orchid product maintained polished surface after 40 autoclave cycles

In both the salt spray and autoclave testing, the Orchid product showed a significant improvement in the corrosion resistance of the material.
