High Impact and Improved Corrosion Resistance 17-4PH Stainless Steel for Rasps, Broaches and Other Bone Cutting Tools

Debbie Arnott ^[1] Tom Smith ^[2]
Orchid Orthopedic Solutions Sheffield Ltd

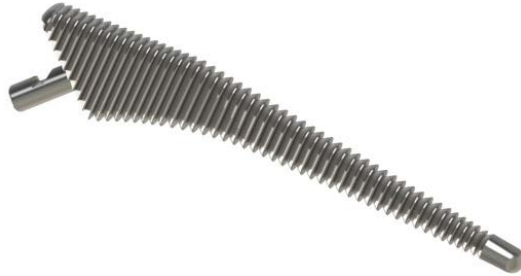
The hip broach (Figure 1), or rasp, is used during implant surgery to form the cavity in the bone into which the hip stem will be implanted. It is manufactured to the same shape as the hip stem with serrated edges to allow removal of the soft tissue and spongy bone from the center of the femoral bone.

Figure 1 – Example of a Hip Broach showing serrated cutting edges.

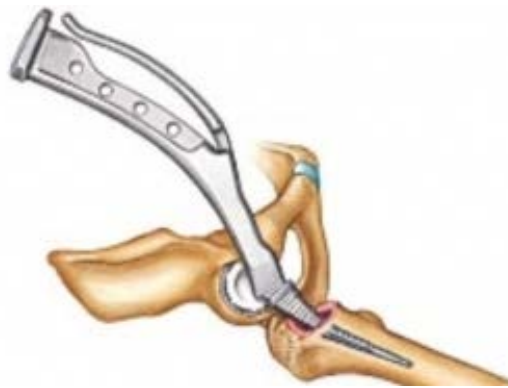
The broach/rasp is inserted into the bone cavity by the use of a detachable handle (Figure 2,) which is attached to a spigot at the end of the rasp stem. The rasp is then repeatedly driven into the cavity by impact force to form the cavity.

Figure 2 – Image showing insertion of the Hip Broach into the Acetabular canal with the use a detachable handle.

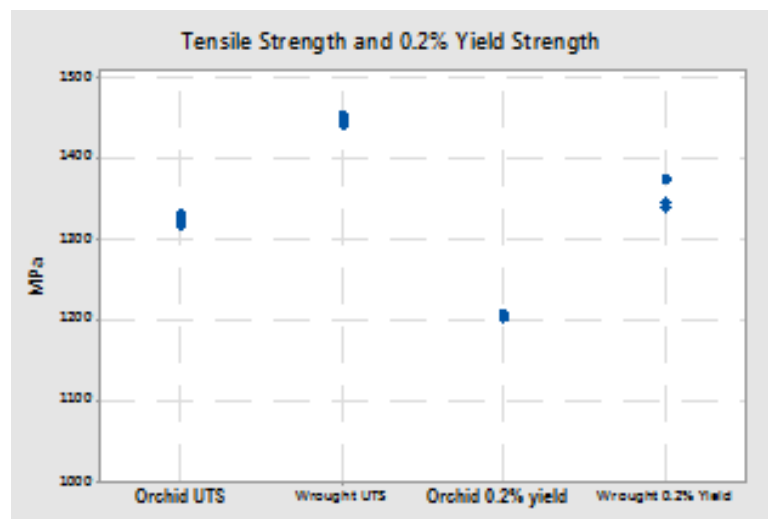
The Tensile strength and 0.2% proof stress is higher in the Standard wrought materials (Figure 5) However, the mechanical properties of both products met the requirements of A564/A564M-13⁽¹⁵⁾ This is combined with a higher ductility in the Orchid material which is product of the heat-treatment process^(5,6,7)

Figure 5 – Comparative Tensile Strength and 0.2% proof stress

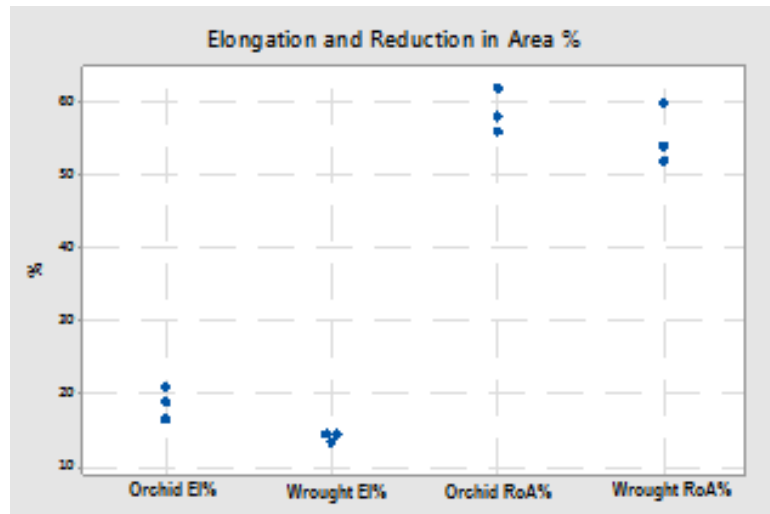
Figure 6 – Comparative Elongation and Reduction of Area Results

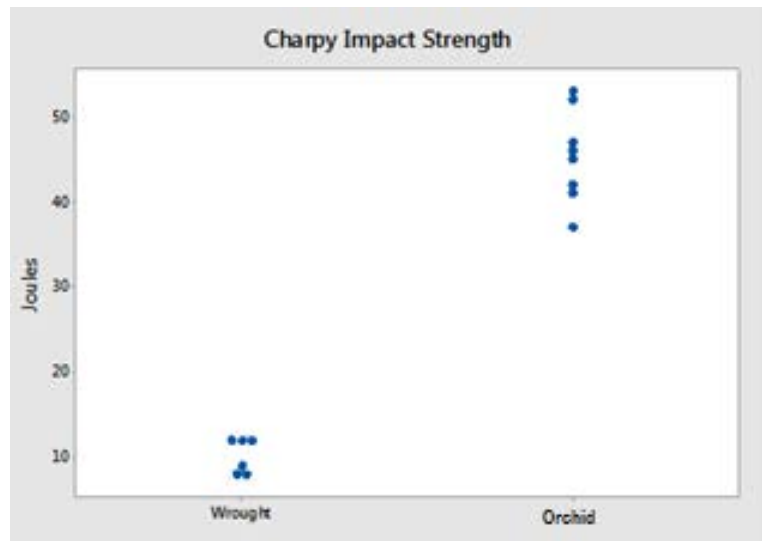
The impact strength of the optimum products was significantly higher in impact strength “**up to 5 times**” when compared to that of **Standard** wrought product (Figure 7). There is evidence to support that there is relationship between the conditions of Heat-treatment and the fracture toughness of the material⁽²⁾.

Figure 7 – Comparative Charpy Impact Strength

This result has the potential to significantly reduce the risk to the patient by producing a material which has up to 5 times the impact strength of the conventional machined and Heat-treated 17/4PH in the H900 condition

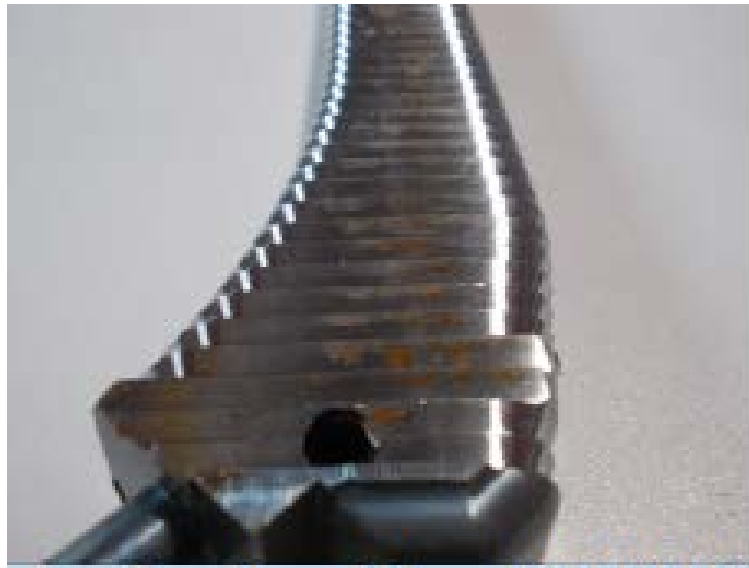
On completion of the test, the Standard wrought product showed evidence of pitting corrosion which initiates from the cutting edges of rasp instruments (Figure 8).

Figure 8- Standard wrought broach showing evidence of Pitting corrosion

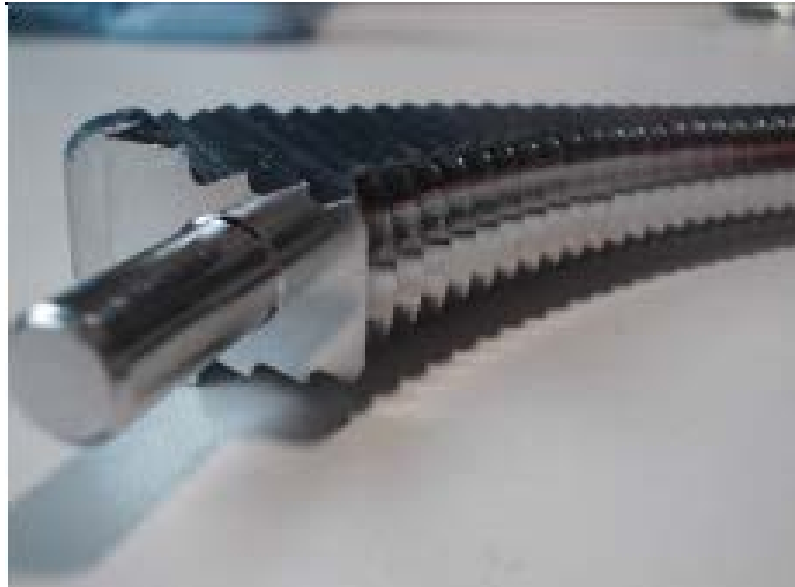
In comparison the Orchid Broach remained in polished condition with no evidence of the corrosion putting on the machined surface (Figure 9)

Figure 9 – Orchid Broach product after Salt Test

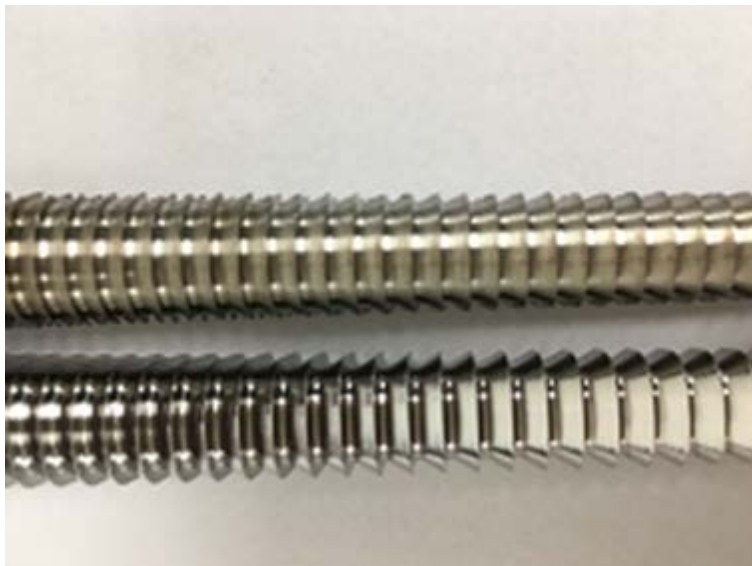
On completion of the autoclave testing, there was no evidence of pitting corrosion. However, after 11 cycles the Standard wrought material displayed a discolouration which was maintained throughout the process (Figure 10). The Orchid product maintained and polished surface after 40 off autoclave cycles.

Figure 10 – Photograph showing discolouration of wrought product at 11 autoclave cycles and Orchid product maintained polished surface after 40 autoclave cycles

In both the salt spray and autoclave testing, the Orchid product showed a significant improvement in the corrosion resistance of the material.
